Product: 1995 Arctic Cat TigerShark Watercraft Service Repair Workshop Manual

# Bulletins & Newsletters

## 1995 Carburetor Recalibration Specifications

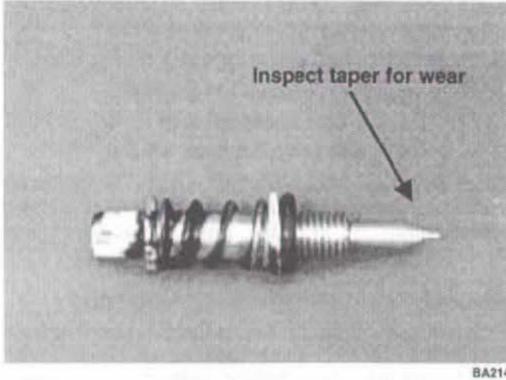
Fig. 2

If a Daytona is running at low RPM (i.e., lower than 6800-7200 RPM) at wide-open-throttle in the water, inspect the taper on the fuel screws (see Fig. 2) for damage. Replace the fuel screw(s) if damage is present. A service bulletin addressing this situation will be out shortly.

■ **NOTE:** There should be no step on the taper.

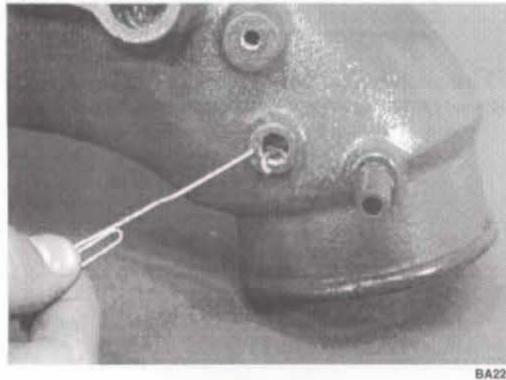
Fig. 3

If you have a problem with straps or exhaust hoses melting on a Tigershark and you have checked all possible causes (blocked intake grate, etc.), there is one of two areas to always check for, depending on the model that is overheating.

If the model has an aluminum expansion chamber equipped with a cast pipe, inspect the bleed hole for obstructions (see Fig. 3).

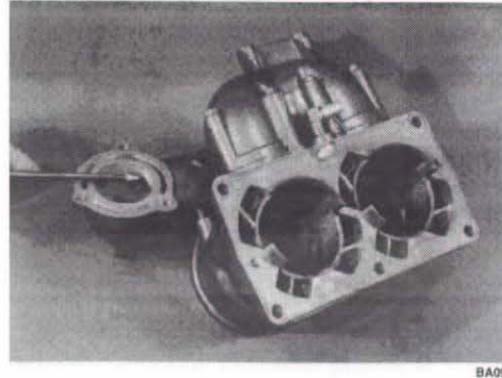
Fig. 4

If the model has a stainless steel expansion chamber, inspect the 5 mm exhaust coolant orifice in the exhaust elbow. It must be clean and unobstructed (see Fig. 4).

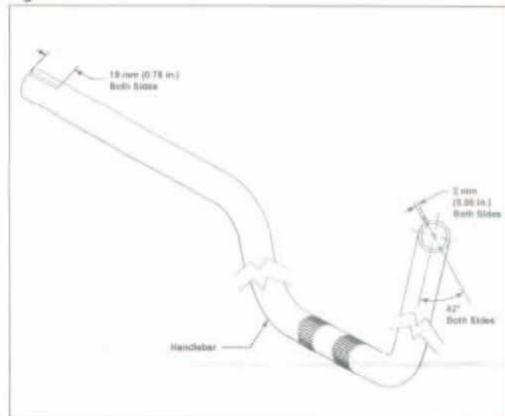
Fig. 1

If any 1995 watercraft have grips that are not satisfactory, replace the existing grips with 1996 Grips (p/n 0673-990), Rivets (p/n 8060-230), and Plugs (p/n 1673-111). Note that both handlebar ends must be slotted typical of the 1996 handlebars so the grip fits correctly. Also, use a high-quality waterproof adhesive when installing the grips.

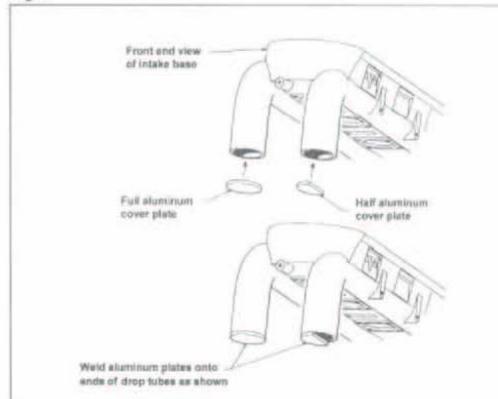
Fig. 2

■ **NOTE:** Only the front drop tubes must be modified.

3. Remove the existing high-speed jet from the MAG-side carburetor and install a No. 85 Jet (p/n 6505-724).
4. Modify the existing intake base according to the illustration.

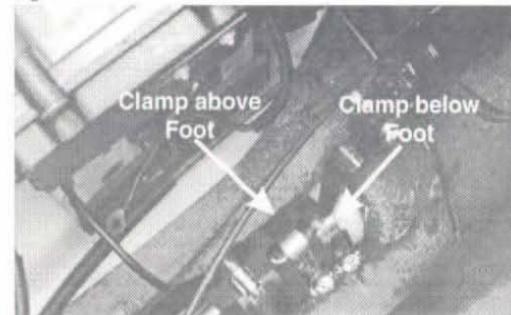
Fig. 3

- A. That the rearward clamp is positioned on the coupler hose only and not positioned over the trim motor bracket foot. . .
- B. That the middle clamp is positioned over the trim motor bracket foot and includes the foot (see Fig. 3).

If the two clamps are positioned correctly, no adjustment is needed.

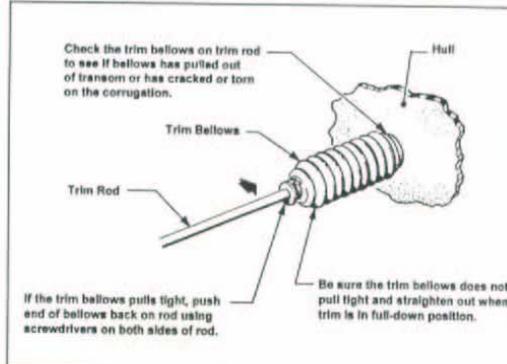
Fig. 1

Please check all Daytona 770 and Monte Carlo 900 for the possibility of an over-extended bellows at full-down trim or a tear or crack on the corrugation that may have occurred during installation. Please fix or replace as necessary.

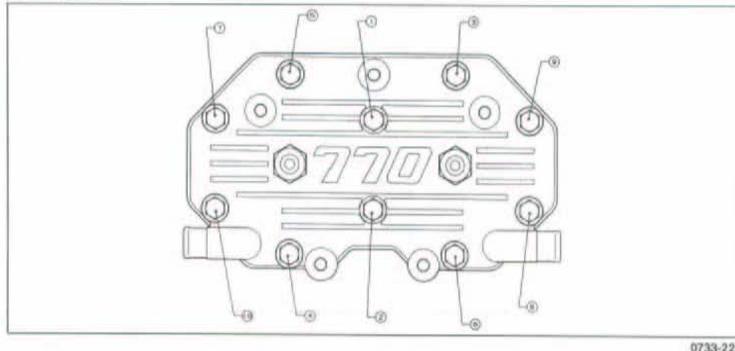
0733-227

**NOTE:** It is critical that the serial number ARJ01167K697 to ARJ02815L697 watercraft have the head bolts tightened to the recommended torque factor or head gasket failure will occur.

**Solution:** Exhaust Brace Kit (p/n 0637-154) and Attenuator Brace Kit (p/n 0637-153) will contain installation instructions. When appropriate, tighten the head bolts to 3.5 kg-m (25 ft-lb) using the pattern shown.

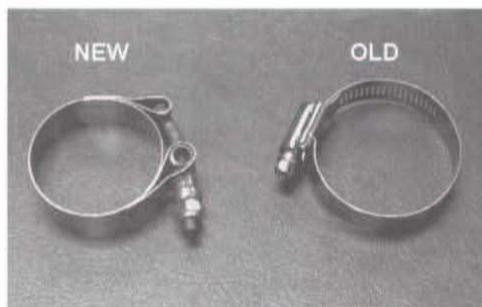
■ **NOTE:** The p/n 0637-158 kits have been available for a period of time, and there is a possibility that the updated clamp may already have been installed on a particular 1997 Daytona watercraft. If this is the case, disregard this bulletin for that watercraft. Visually inspect the existing hose clamp and use Fig. 1 to determine the presence of the "old" or "new" clamp.
