YAMAHA MEASURE REPORT

REF. No. MC-88049

MODEL	TDR240/250, TZR250	FILE	
SUBJECT	PISTON MELTING AT CROWN

MODEL	TZR250 '87, '88	FILE	
SUBJECT	PISTON SEIZURE

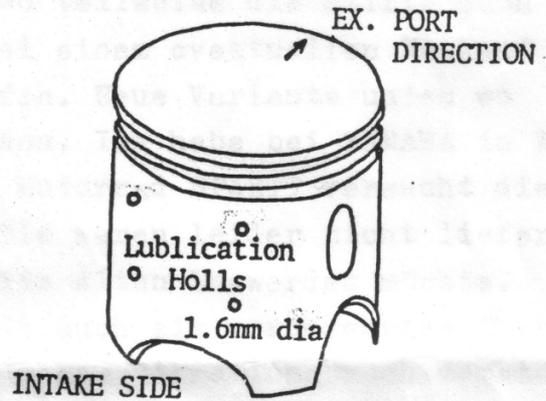
Market report indicate knocking engine noise and piston seizure.

At the early breake-in of an units, some units may be experienced scuffing between piston and cylinder wall insurficiant lubrication. Then scuffing caused to piston seizure.

To prevent scuffing at early breake-in, we are going to change the piston design as similure with 2YK type (TDR250) as a next model. The 2YK type piston has four location of lubrication holls at intake side as shoun in the left. These holls will provide greater lubrication effect between piston and cylinder wall comparison with present ones.

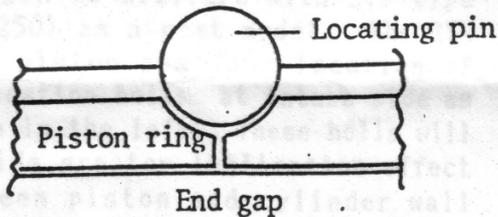
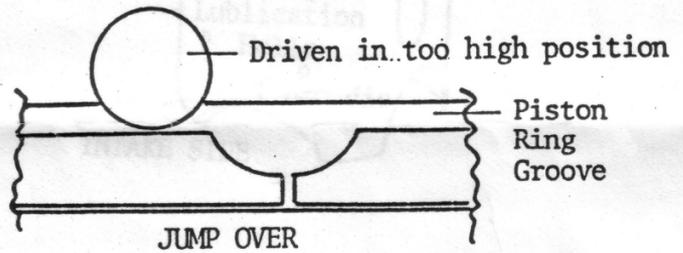
Alte Variante

Market report indicates that the a piston ring is broken catching with cylinder port.

The piston ring located pin may be experienced driving into piston ring groove with insufficient dimension accuracy in some units (drivig upward comparison with specified location) . And also locating pin can be worn. These matter may cause that piston ring end gap can jump over the locating pin and then end gap will catch with cylinder ports. See below.
