FORD - NEW HOLLAND - VERSATILE

SERVICE JOURNAL

Issue 11-12/93

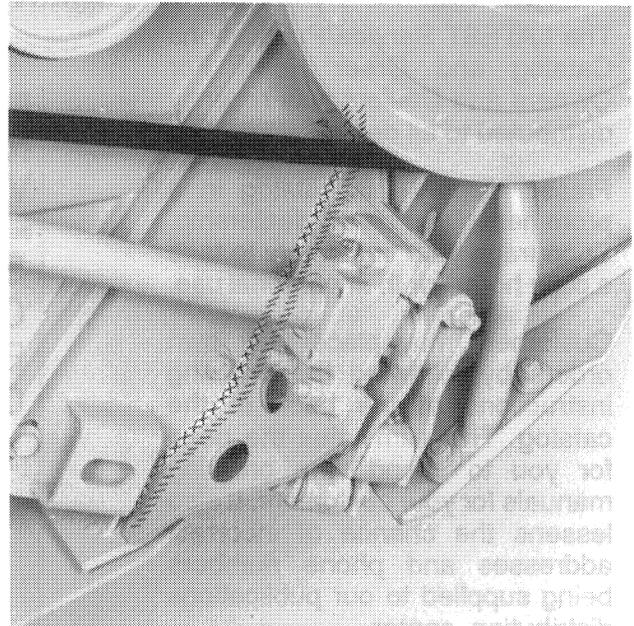
FIGURE 1

Missing or poor penetration of the weld on the right side of the header frame around the support for the yoke shaft bearing.

Check the right side of the headers for poor weld penetration and missing welds. There should be a continuous 3/8" bead of weld around the entire support, as shown in Figure 1. If incorrect, grind away existing weld, which has not penetrated, and reweld.

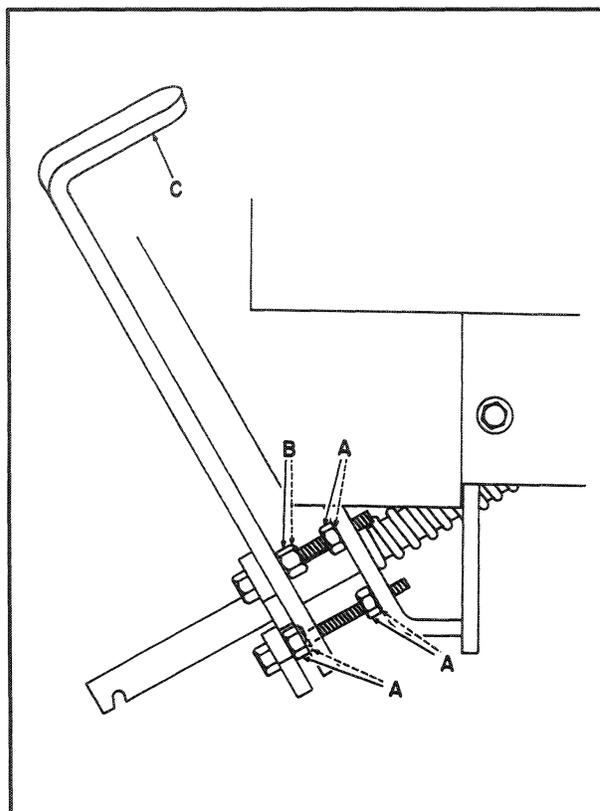
FIGURE 1

1. Shields cracking can be caused by:
 - a. Incorrect assembly of the table latch.
 - b. Misadjusted table latch.
 - c. Shielding installed incorrectly or the over-center latches not properly adjusted.
 - d. Excessive tire pressure.
 - e. Excessive ground speed for field conditions.
2. Replacement shielding and supports were redesigned to increase durability.

The table latch must be assembled correctly to keep table bounce to a minimum. Jam nuts must be used at A, Figure 1, and locknuts at B, against the latch handle.

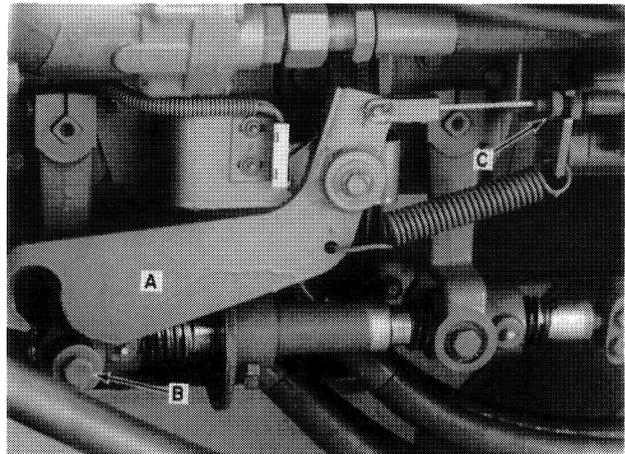
FIGURE 1

1. With the FNR lever aligned with the reverse slot, neutral lock arm, A, Figure 1, has not been lifted completely off of lockpin, B.
2. The open end of the telescoping double U-joint shaft, under the cab, is up and full of dirt, not allowing it to slide together.

1. Adjust the neutral cable at C, Figure 1, so there is no interference between bracket, A, and pin, B, when the FNR lever is at the reverse slot.

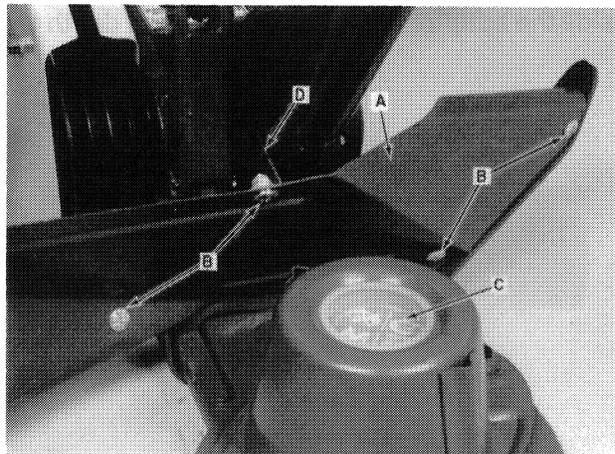
FIGURE 1

1. Incorrect assembly of the inner swathboard, A, Figure 1.
2. An elevated end cone is used to reduce knife contact during operation.

1. Rotate the inside disc to check for clearance between the knife tip and swathboard. Loosen the hardware and force the swathboard upwards to clear the knives and then retighten the hardware. If the knives still do not clear, modify the swathboard by cutting a notch in the bottom, as shown in Figure 2. Replacement swathboards, part #274108, are notched to alleviate knife interference.
2. Notched swathboards were installed in production on Models 442 to 463 above serial #930001 and Model 465 above serial #920001.

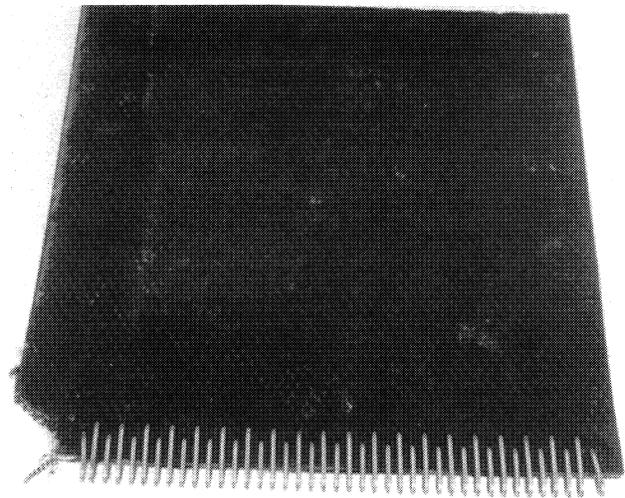
Figure 5

This belt has a corner missing at the lacing. This was caused by a foreign object or belt tracking. No repair is needed on this belt as it will not cause a problem with the performance of the baler.
