FORD - NEW HOLLAND - VERSATILE

SERVICE JOURNAL

Issue 11-12/93

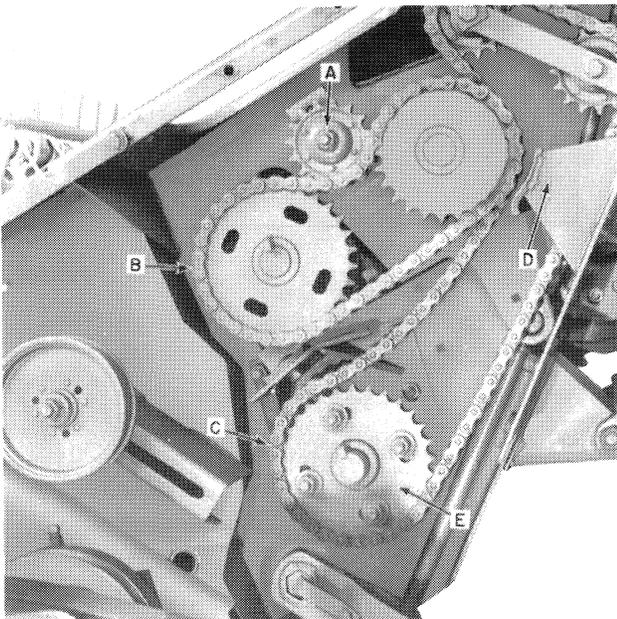
FIGURE 1

Improper chain tension on the conditioner roll drive sprockets can lead to conditioner roll stub shaft and/or bearing failure.

2. Measure the chain deflection in the center of the longest span.
3. Loosen idler bracket, A, Figure 1, and adjust upper roll drive chain, B, to 1/8" - 1/4" (3.2 - 6.3 mm). Retighten the idler hardware.
4. Adjust lower roll drive chain, C, to deflect 1/2" (12.7 mm) in the center of the longest span. Loosen bolt, A, Figure 2, and adjust eyebolt, B, until the chain tension is correct. Retighten the adjuster hardware.

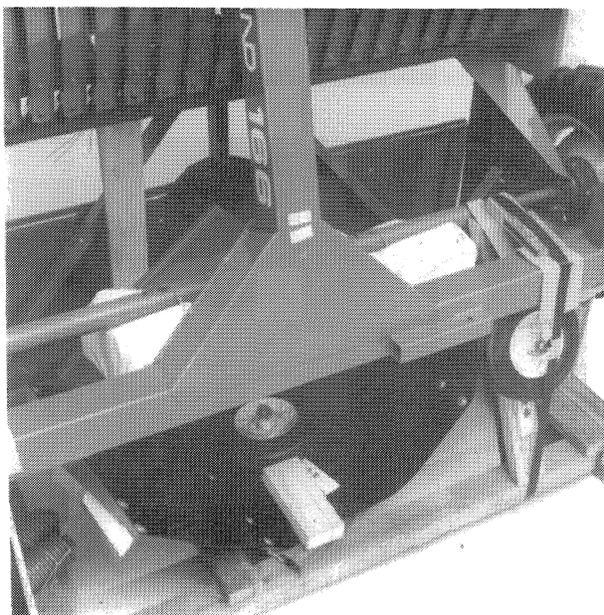
FIGURE 1

Conveyor belt deterioration from prolonged storage.

The conveyor belt(s) should not be installed until the unit is ready for retail delivery. Windrow inverters above serial #882684 will be shipped without the conveyor belt installed on the main table. The belt will be packaged in plastic, as shown in Figure 1, to prevent deterioration from prolonged storage.

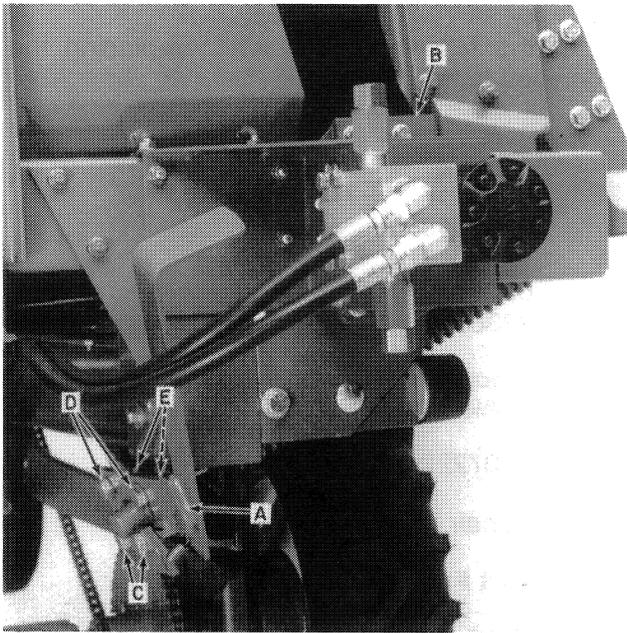
FIGURE 2

1. Extension side shields may crack around the mounting pin hole.
2. Replacement shields will not mount to the extension table.

1. Shields cracking can be caused by:
 - a. Incorrect assembly of the table latch.
 - b. Misadjusted table latch.
 - c. Shielding installed incorrectly or the over-center latches not properly adjusted.
 - d. Excessive tire pressure.
 - e. Excessive ground speed for field conditions.
2. Replacement shielding and supports were redesigned to increase durability.

1. If the extension table shielding is cracked around the mounting pin holes, order repair kit # 86507220. Severely damaged shielding should be replaced and corrective action taken, as described in items a through e.
